**Flood Control Project Maintenance  
Levee Inspections**  
**LMA District Cover Sheet**  
**Spring 2019 Levee Inspection Results**

**Lake County Watershed Protection District**

**Spring 2019 Levee Inspection Results**

Waterway			Bank	Unit Miles
Unit No. 01 Middle Creek			Left	3.35
	Spring (March - May)	Summer (June - August)	(September - November) Fall	Winter (December - February)
Unit Maintenance Rating (Fall Only)				
Date of Inspection	4/11/2019 - 5/24/2019			
DWR Inspector	Luz Dial			
Accompanied By	Scott Webb Lake County			
	James Davis Lake County			
	Saskia Dononvan DWR

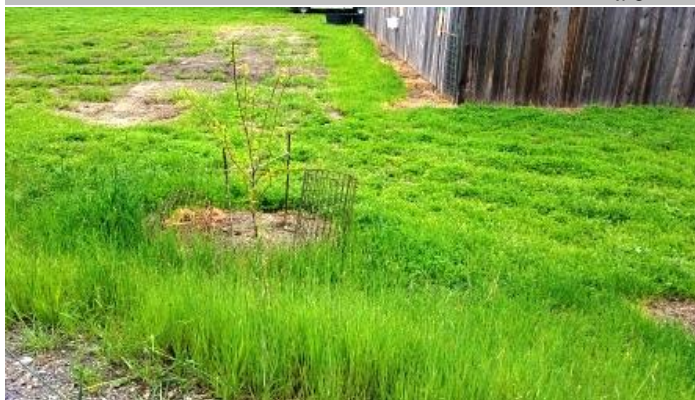
Photo 2 of 2 : SP\_2019\_NA0009\_3\_34\_20190415\_00037.jpg

View of newly planted trees within landside toe easement. Spring 2019

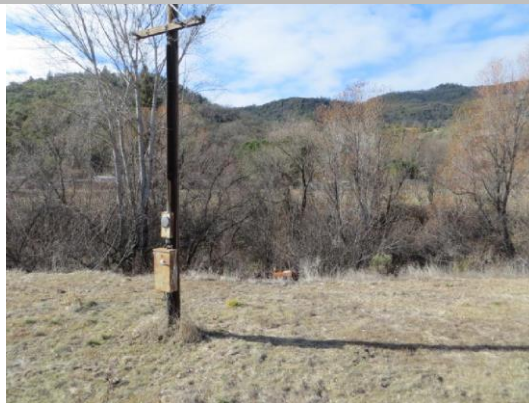
Photo 2 of 3 : UCIP\_SP\_2019\_26943\_49781.jpg

Power pole, meter, and pump visible on WS berm.

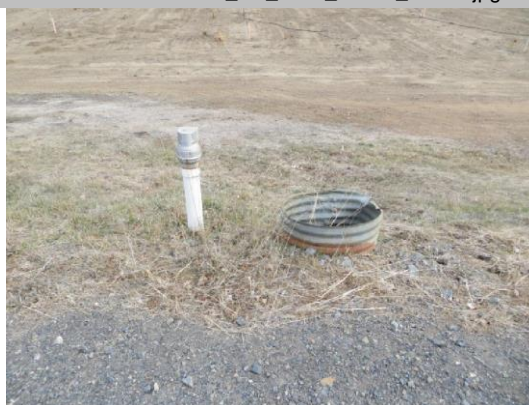
Photo 1 of 3 : UCIP\_SP\_2019\_26946\_49789.jpg

LM Start	0.84	Rating **	M	Issue No.	536	
LM End	0.84	Issue Type +	En	Location *		
Category	Supplemental			GPS Latitude/Longitude		
				Start		End
Item	DWR UCIP Field Study			39.179534 °	39.179534 °	
				-122.912512 °	-122.912512 °	
DWR ID	21196					
Comment Code						
Inspector Comment						
FS_ID:26946 DS_ID:21196 EP_NO: N/A Repair Type: Non-Urgent Crossing Status: Found UCIP Comments: Pump and pipe appear abandoned and should be done so properly. FIELD_STRUCT_DESC: *ABANDONED* 8-inch steel irrigation pipe through the levee, 3 feet below the crown. Siphon breaker in 24-inch corrugated metal riser unit on the landside (LS) slope. Pump on the waterside (WS) bank with a butterfly valve. Service pole on the WS berm. (Moitozo Brothers, Inc.). [Additional Reference(s): DWR Levee Log, 2005. USACE Sacramento O&M Manual 506.2, August 1961, (HLM 0.83)]. FS Date: 1/9/2014

Siphon breaker in 24-inch cmp riser with vent on LS shoulder.

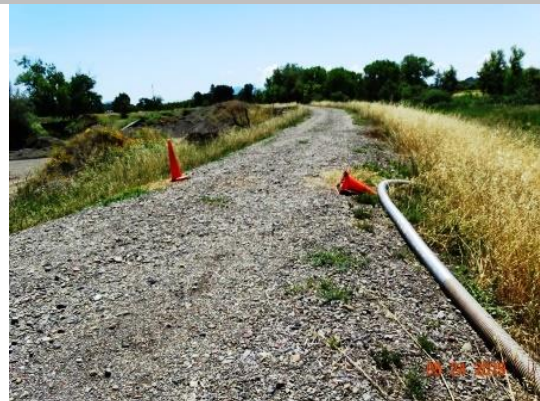
Photo 2 of 2 : SP\_2019\_NA0009\_3\_45\_20190524\_00039.jpg

View looking downstream at a metal hose that ran across the levee crown.  
Spring 2019

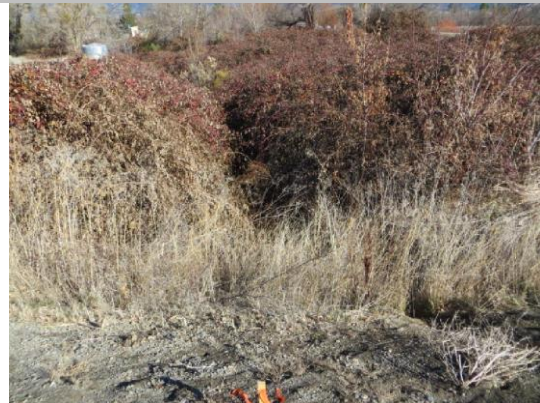
Photo 1 of 3 : UCIP\_SP\_2019\_26987\_49853.jpg

LM Start	2.26	Rating **	A/W	Issue No.	537
LM End	2.26	Issue Type +	Ma	Location *	
Category	Supplemental			GPS Latitude/Longitude	
				Start	End
Item	DWR UCIP LMA Responsibility			39.160327°	39.160327°
				-122.913998°	-122.913998°
DWR ID	21240				
Comment Code					
Inspector Comment					
FS_ID:26987 DS_ID:21240 EP_NO: N/A Repair Type: No Action Needed Crossing Status: Found UCIP Comments: FIELD_STRUCT_DESC: 2 of 2: 36-inch corrugated metal drainage pipe through the levee, 9 feet below the crown. Flap gate on the waterside (WS) end. Concrete headwalls on both ends. (two 36-inch pipes [HLM 2.26] retained under Automatic Board Order (ABO) issued as Permit No. 11460, 1975 - Robert L. and Lavona Gentry). [Additional Reference(s): DWR Levee Log, 2005. USACE Sacramento O&M Manual 506.2, August 1961, (HLM 2.26)]. FS Date: 1/14/2014

Pipe and Concrete headwall visible on LS toe.

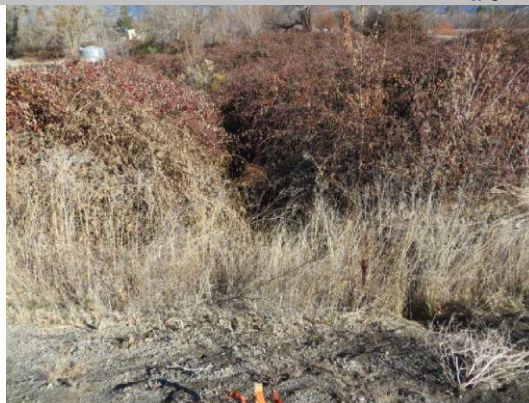
Photo 1 of 3 : UCIP\_SP\_2019\_26986\_49849.jpg

LM Start	2.26	Rating **	A/W	Issue No.	538
LM End	2.26	Issue Type +	Ma	Location *	
Category	Supplemental			GPS Latitude/Longitude	
				Start	End
Item	DWR UCIP LMA Responsibility		39.160272 °	39.160272 °	
			-122.913966 °	-122.913966 °	
DWR ID	21197				
Comment Code					
Inspector Comment					
FS_ID:26986 DS_ID:21197 EP_NO: N/A Repair Type: No Action Needed Crossing Status: Found UCIP Comments: FIELD_STRUCT_DESC: 1 of 2: 36-inch corrugated metal drainage pipe through the levee, 9 feet below the crown. Flap gate on the waterside (WS) end. Concrete U-shaped headwalls on both ends. (two 36-inch pipes [HLM 2.26] retained under Automatic Board Order (ABO) issued as Permit No. 11460, 1975 - Robert L. and Lavona Gentry). [Additional Reference(s): DWR Levee Log, 2005. USACE Sacramento O&M Manual 506.2, August 1961, (HLM 2.26)]. FS Date: 1/9/2014

Concrete headwall and pipe visible on LS toe at end of drainage swale.

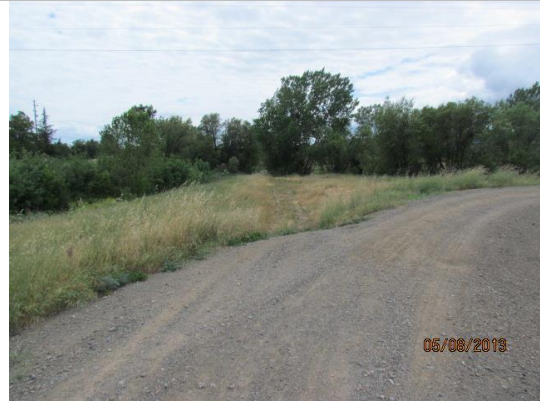
Photo 1 of 1 : SP\_2019\_NA0009\_3\_13\_20190411\_00007.jpg

LM Start	2.29	Rating **	M	Issue No.	13
LM End	2.29	Issue Type +	Ma	Location *	WS
Category	Earthen Levee			GPS Latitude/Longitude	
				Start	End
Item	Slope Stability			39.160285 °	39.160285 °
				-122.913481 °	-122.913481 °
DWR ID	DWR_NA0009_01_s_2013_13				
Comment Code					
S3 : Repair the levee slope damaged by vehicle traffic and prevent access where possible.					
Inspector Comment

View of the vehicle erosion along the waterside slope.

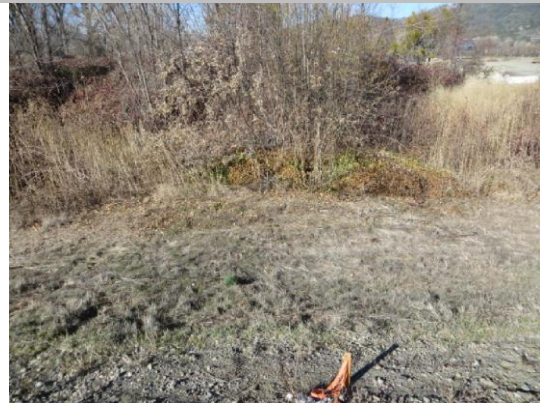
Photo 1 of 3 : UCIP\_SP\_2019\_27004\_49862.jpg

LM Start	2.35	Rating **	M	Issue No.	539	
LM End	2.35	Issue Type +	Ma	Location *		
Category	Supplemental			GPS Latitude/Longitude		
				Start	End	
Item	DWR UCIP LMA Responsibility			39.161002 °	39.161002 °	
				-122.912843 °	-122.912843 °	
DWR ID	21199					
Comment Code						
Inspector Comment						
FS_ID:27004 DS_ID:21199 EP_NO: 11460 Repair Type: Non-Urgent Crossing Status: Found UCIP Comments: Heavy vegetation on LS at inlet should be removed. FIELD_STRUCT_DESC: 42-inch corrugated metal drainage pipe through the levee, 10 feet below the crown. Flap gate on the waterside (WS) end. Concrete headwall on both ends. (42-inch pipe [HLM 2.35] retained under Automatic Board Order (ABO) issued as Permit No. 11460, 1975 - Robert L. and Lavona Gentry). [Additional Reference(s): DWR Levee Log, 2005. USACE Sacramento O&M Manual 506.2, August 1961, (HLM 2.35)]. FS Date: 1/14/2014

Heavy vegetation at inlet on LS toe.

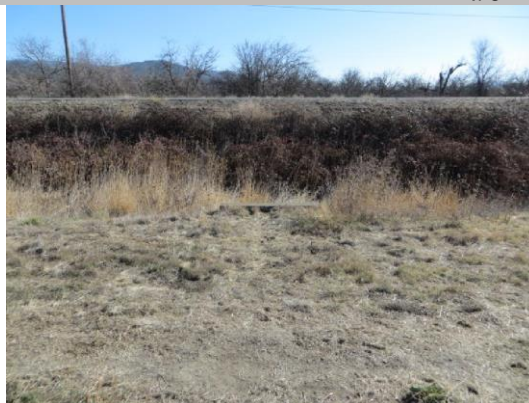
Photo 2 of 3 : UCIP\_SP\_2019\_27004\_49861.jpg

Concrete U-shaped headwall on WS berm.

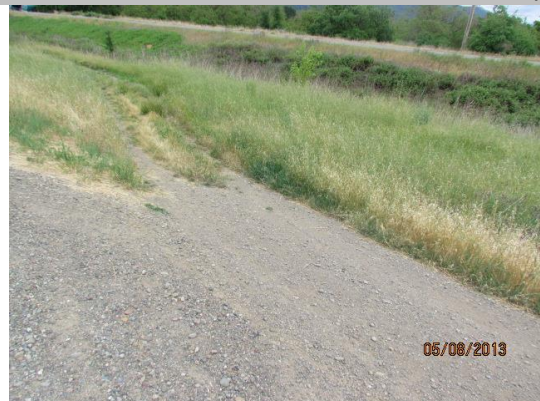
Photo 1 of 1 : SP\_2019\_NA0009\_3\_14\_20190411\_00008.jpg

LM Start	2.36	Rating **	A/W	Issue No.	14
LM End	2.36	Issue Type +	Ma	Location *	WS
Category	Earthen Levee			GPS Latitude/Longitude	
				Start	End
Item	Slope Stability			39.161153°	39.161153°
				-122.912740°	-122.912740°
DWR ID	DWR_NA0009_01_s_2013_14				
Comment Code					
S3 : Repair the levee slope damaged by vehicle traffic and prevent access where possible.					
Inspector Comment

View of the vehicle erosion along the waterside slope.

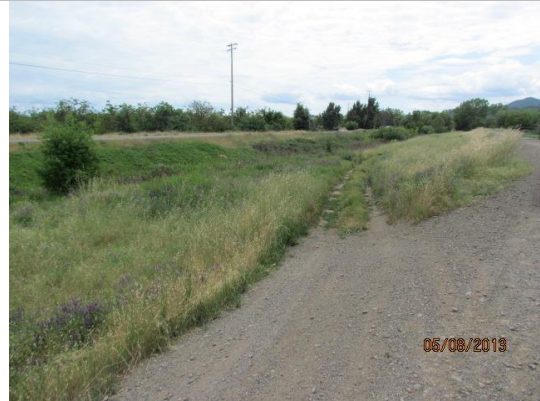
Photo 1 of 1 : SP\_2019\_NA0009\_3\_16\_20190411\_00010.jpg

LM Start	2.40	Rating **	M	Issue No.	16
LM End	2.40	Issue Type +	Ma	Location *	WS
Category	Earthen Levee			GPS Latitude/Longitude	
				Start	End
Item	Slope Stability			39.161601 °	39.161601 °
				-122.912303 °	-122.912303 °
DWR ID	DWR_NA0009_01_s _ 2013_16				
Comment Code					
S3 : Repair the levee slope damaged by vehicle traffic and prevent access where possible.					
Inspector Comment

View of the vehicle erosion along the waterside slope.

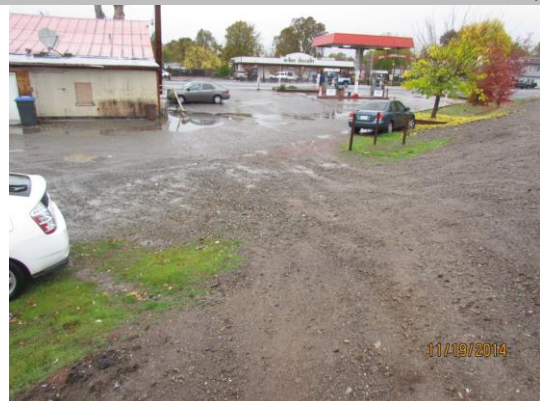
Photo 1 of 1 : SP\_2019\_NA0009\_3\_17\_20190411\_00011.jpg

LM Start	2.42	Rating **	M	Issue No.	17
LM End	2.42	Issue Type +	Ma	Location *	LS
Category	Earthen Levee			GPS Latitude/Longitude	
				Start	End
Item	Slope Stability			39.161802 °	39.161802 °
				-122.912020 °	-122.912020 °
DWR ID	DWR_NA0009_01_s _ 2013_17				
Comment Code					
S3 : Repair the levee slope damaged by vehicle traffic and prevent access where possible.					
Inspector Comment

View of the erosion caused by vehicle along the landside slope.

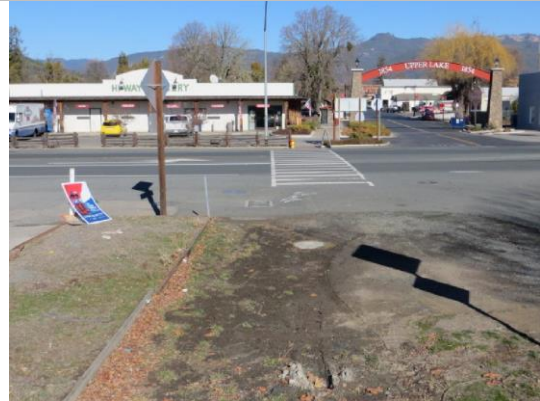
Photo 3 of 3 : UCIP\_SP\_2019\_53326\_50040.jpg

Stormdrain drop inlet visible at edge of pavement on HWY 20.

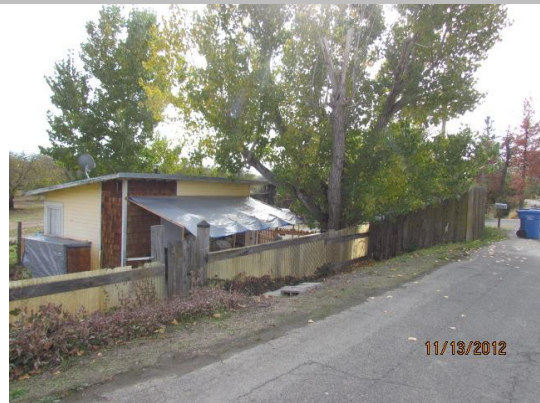
Photo 1 of 1 : SP\_2019\_NA0009\_3\_7\_20190411\_00005.jpg

View of a building & fence along the toe of the levee.

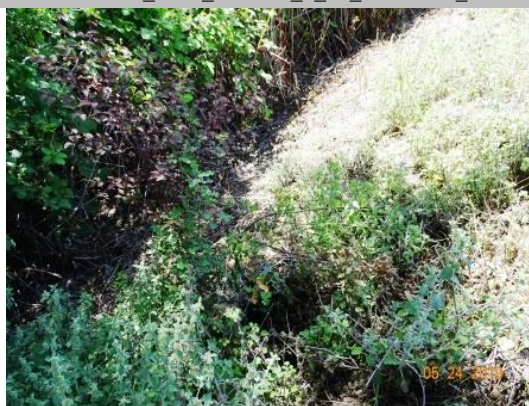
Photo 1 of 2 : SP\_2019\_NA0009\_3\_48\_20190524\_00040.jpg

View looking downstream at animal holes on the landside slope. Spring 2019

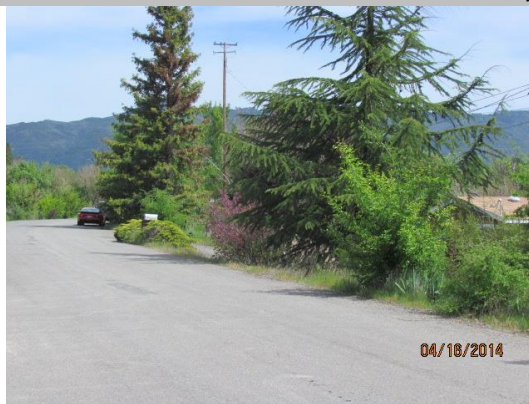
Photo 1 of 1 : SP\_2019\_NA0009\_3\_5\_20190411\_00004.jpg

View of the landscape along the landside slope.

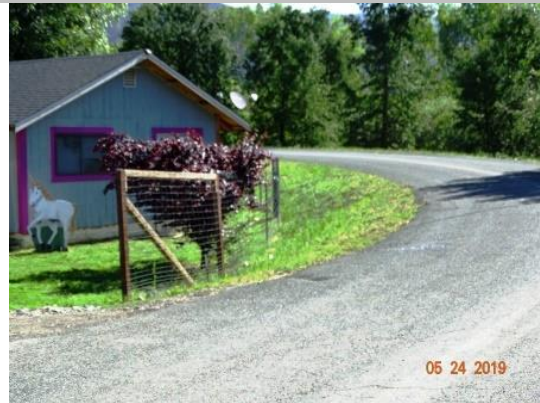
Photo 1 of 1 : SP\_2019\_NA0009\_4\_33\_20190524\_00050.jpg

View looking upstream at a metal and wooden fence at the levee toe.  
Spring 2019

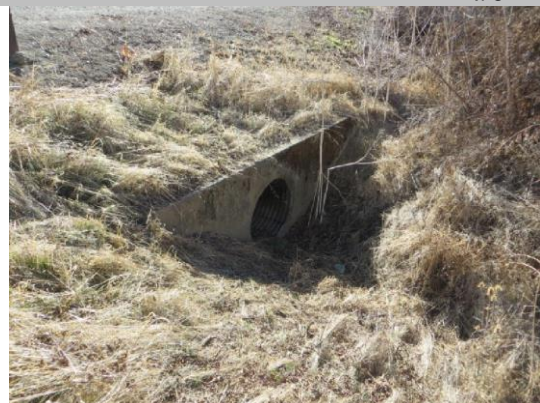
Photo 1 of 3 : UCIP\_SP\_2019\_27184\_50322.jpg

Concrete headwall and pipe on LS toe.

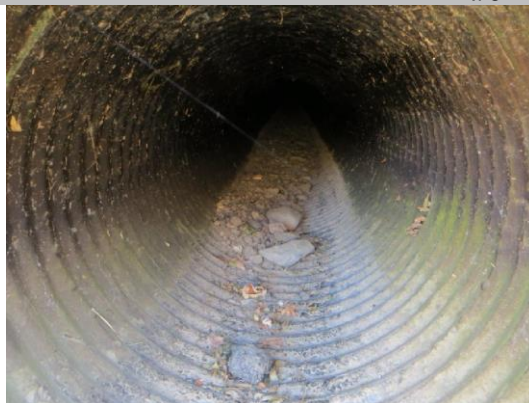
Photo 2 of 3 : UCIP\_SP\_2019\_27184\_50321.jpg

Pipe at inlet.

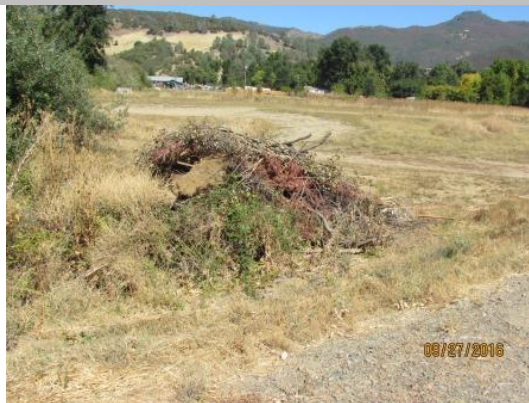
Photo 1 of 1 : SP\_2019\_NA0009\_4\_17\_20190411\_00007.jpg

View of the prunings along the landside toe.

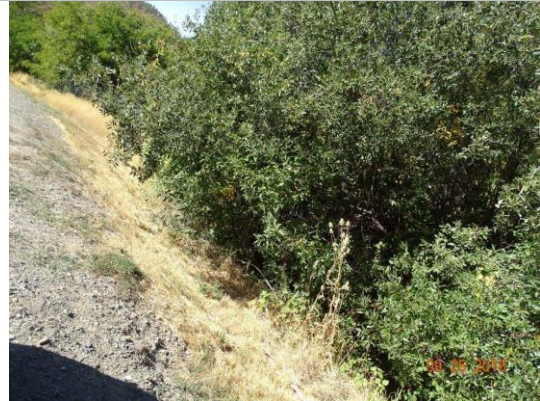
Photo 1 of 1 : SP\_2019\_NA0009\_4\_29\_20190411\_00011.jpg

View of the trees along the landside slope and toe.

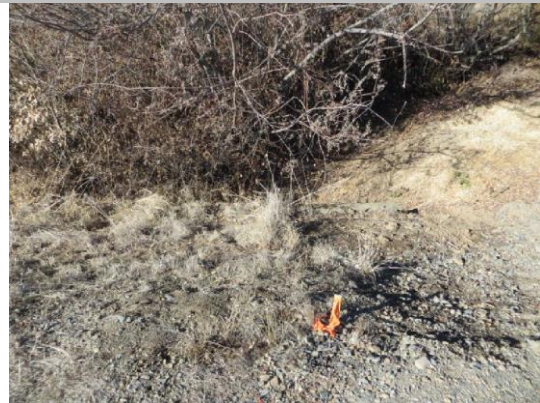
Photo 1 of 3 : UCIP\_SP\_2019\_27192\_50326.jpg

Pipe and concrete headwall at LS toe.

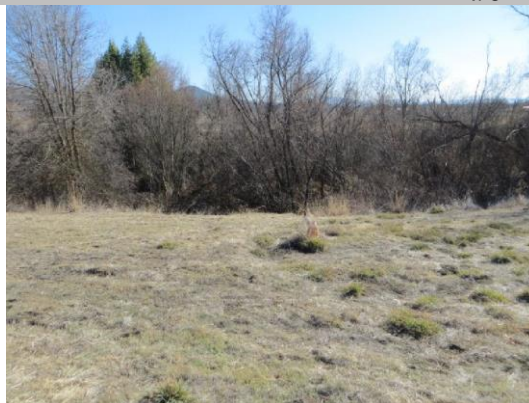
Photo 2 of 3 : UCIP\_SP\_2019\_27192\_50325.jpg

Flapgate and headwall off WS toe at berms edge.

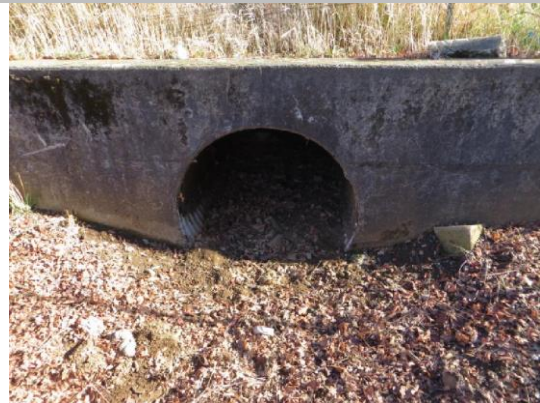
Photo 1 of 3 : UCIP\_SP\_2019\_27199\_50389.jpg

Concrete headwall on LS toe.

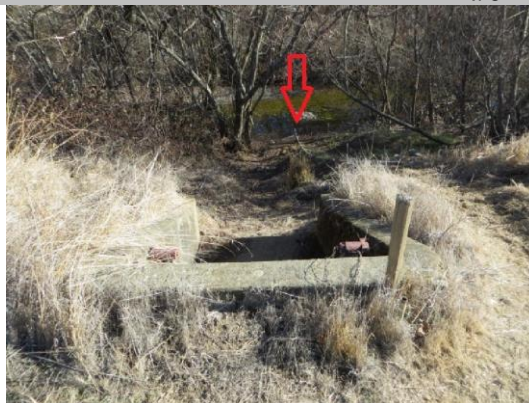
Photo 1 of 3 : UCIP\_SP\_2019\_27563\_51182.jpg

Pipe visible just downstream from stormdrain.

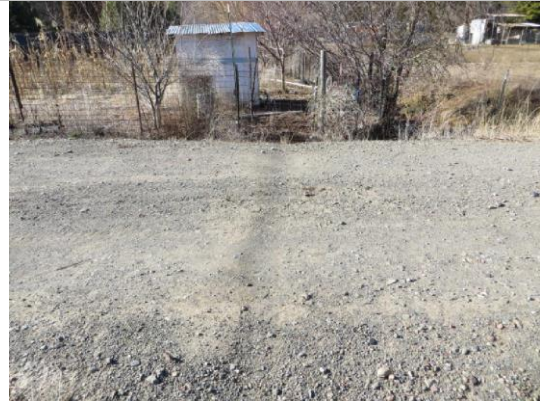
Photo 3 of 3 : UCIP\_SP\_2019\_27563\_51180.jpg

cut across levee crown visible along pipe alignment.

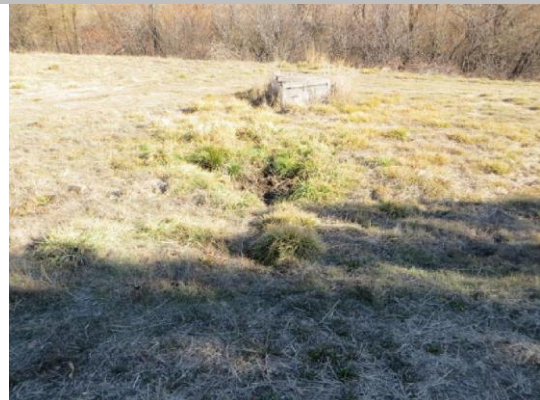
Photo 2 of 3 : UCIP\_SP\_2019\_52935\_50392.jpg

Mudpit at WS berm where pipe may be leaking.

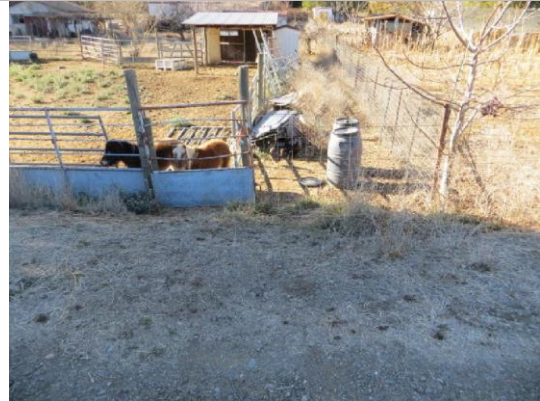
Photo 3 of 3 : UCIP\_SP\_2019\_52935\_50391.jpg

Valves visible just off LS toe.

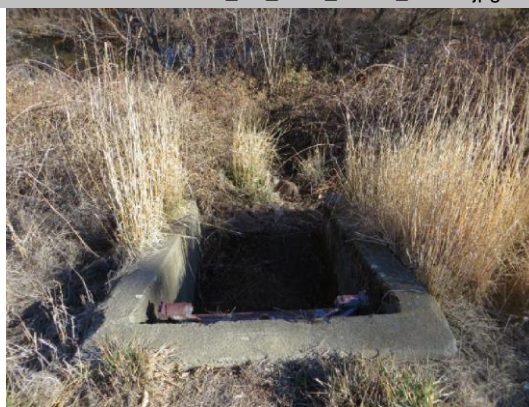
Photo 2 of 3 : UCIP\_SP\_2019\_27208\_50410.jpg

Flapgate and concrete headwall on WS berm.

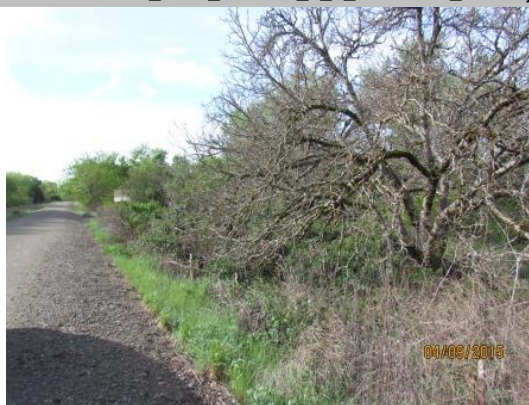
Photo 1 of 1 : SP\_2019\_NA0009\_4\_7\_20190411\_00004.jpg

View of the vegetation at the landside toe.

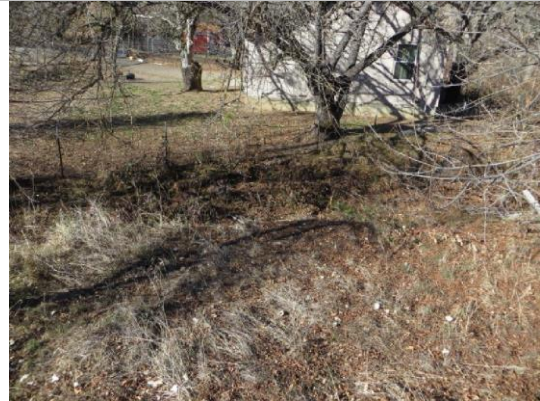
Photo 3 of 3 : UCIP\_SP\_2019\_27583\_51200.jpg

Pipe visible on LS toe.

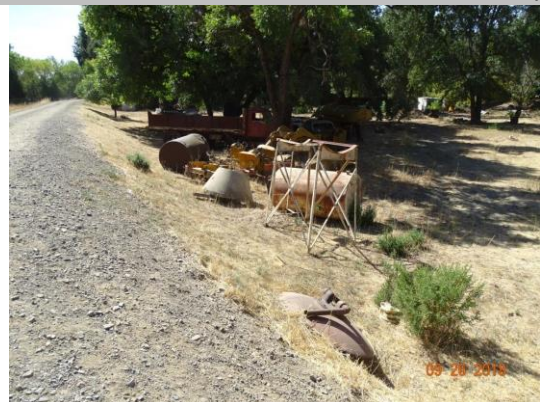
Photo 1 of 1 : SP\_2019\_NA0009\_4\_31\_20190411\_00013.jpg

View of equipment along the landside toe.

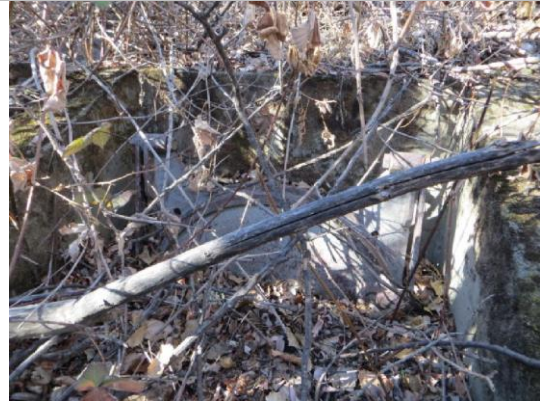
Photo 3 of 3 : UCIP\_SP\_2019\_42994\_51215.jpg

Flapgate and concrete headwall visible off WS berm.

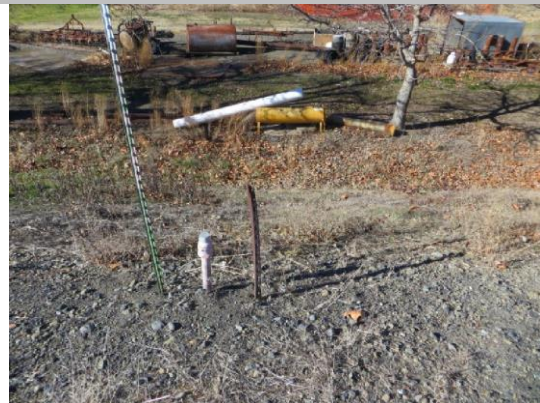
Photo 1 of 2 : UCIP\_SP\_2019\_27606\_51250.jpg

Vent on LS shoulder with filter visible on LS toe.

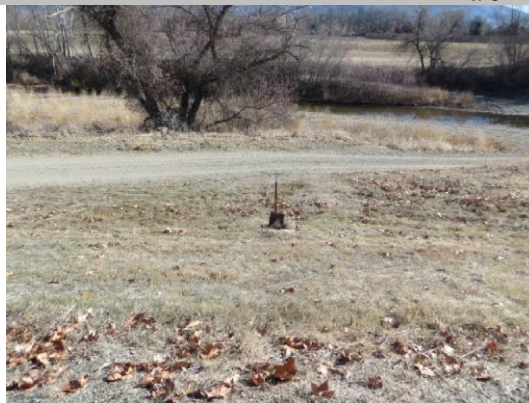
Photo 2 of 2 : UCIP\_SP\_2019\_27606\_51249.jpg

T-post at WS toe may indicate location of pipe end. Covered with soil.

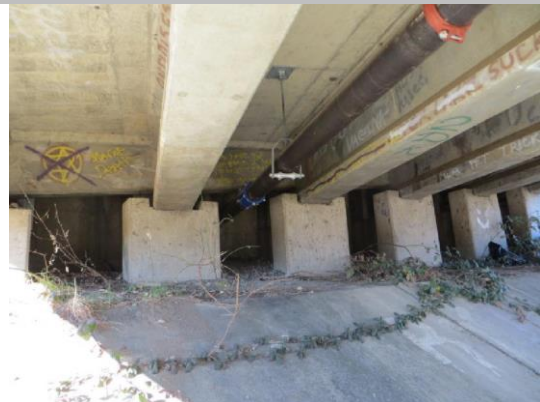
Photo 1 of 2 : UCIP\_SP\_2019\_27624\_51263.jpg

Pipe visible under bridge.

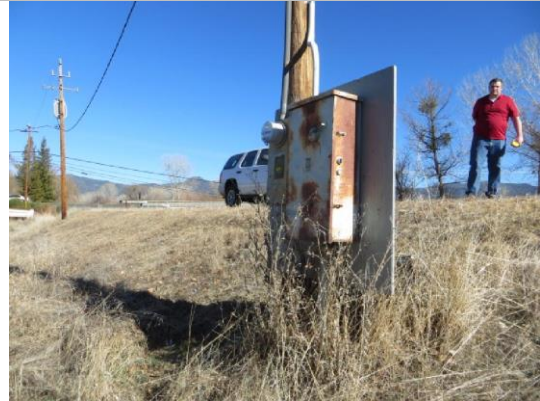
Photo 2 of 2 : UCIP\_SP\_2019\_27629\_51279.jpg

Meter and control on LS slope next to pole.

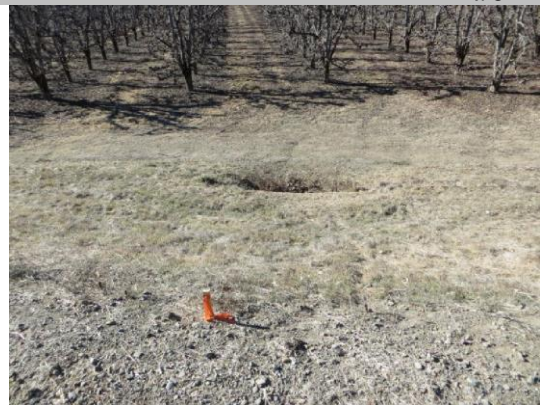
Photo 1 of 3 : UCIP\_SP\_2019\_27630\_51283.jpg

Concrete headwall and pipe visible at LS toe.

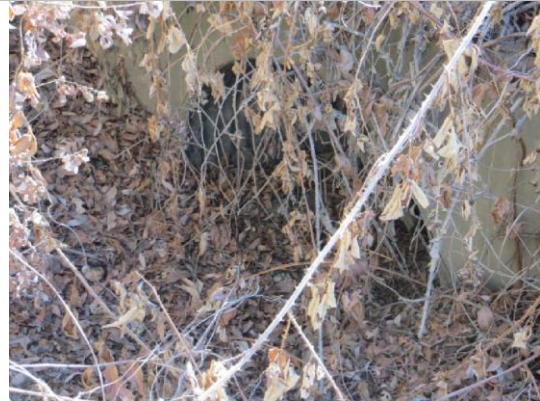
Photo 3 of 3 : UCIP\_SP\_2019\_27894\_51597.jpg

Concrete headwall on LS toe.

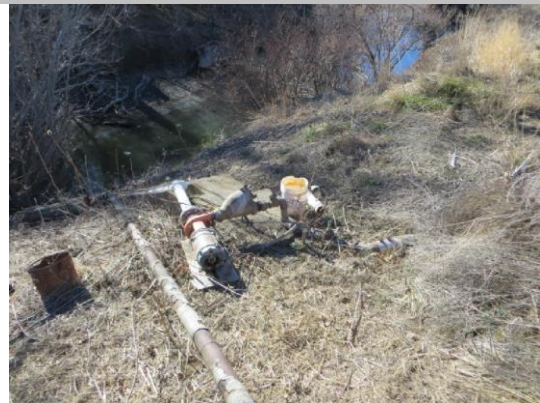
Photo 1 of 3 : UCIP\_SP\_2019\_27903\_51622.jpg

Pump at concrete pad on WS berm.

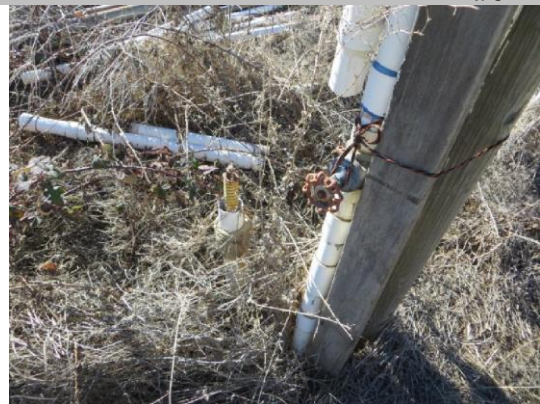
Photo 3 of 3 : UCIP\_SP\_2019\_27903\_51620.jpg

filler valves on LS toe.

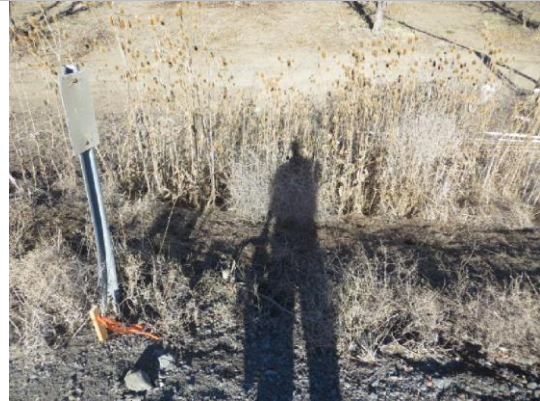
Photo 3 of 3 : UCIP\_SP\_2019\_27943\_51640.jpg

Pipe location marked on crown by flasher.

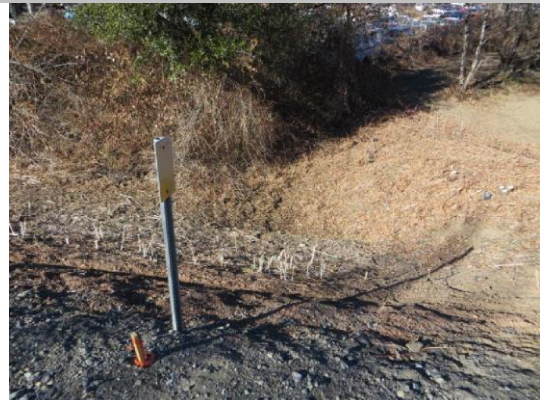
Photo 1 of 3 : UCIP\_SP\_2019\_27944\_51646.jpg

Flasher on crown marks pipe location.

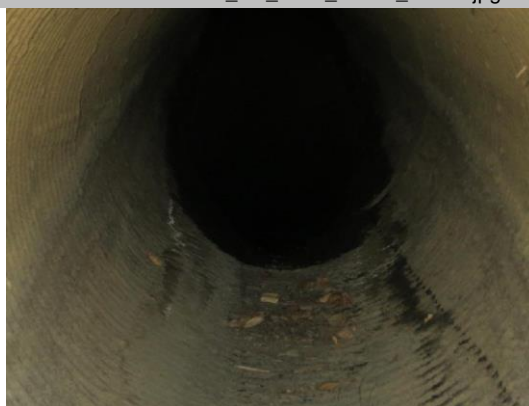
Photo 2 of 3 : UCIP\_SP\_2019\_27964\_51664.jpg

Pipe from LS toe.

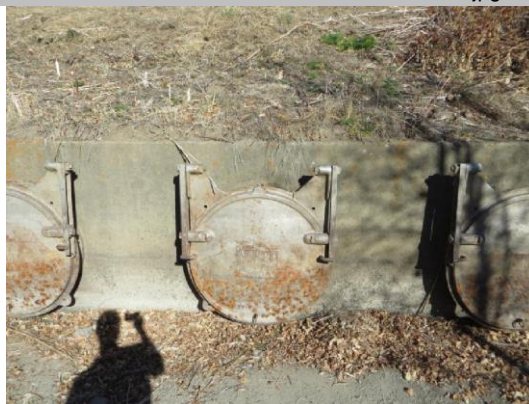
Photo 3 of 3 : UCIP\_SP\_2019\_27964\_51663.jpg

Flapgate and headwall on WS toe.

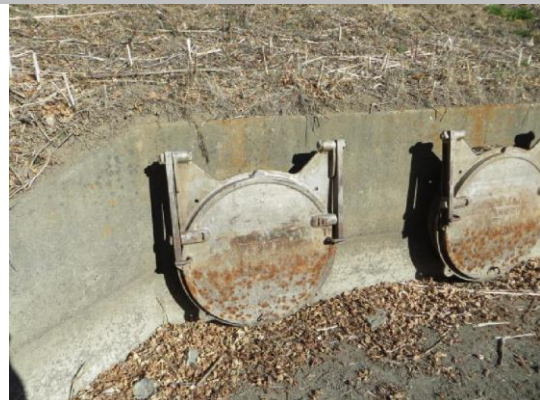
Photo 3 of 3 : UCIP\_SP\_2019\_27967\_51669.jpg

Flapgate on concrete headwall on WS toe.

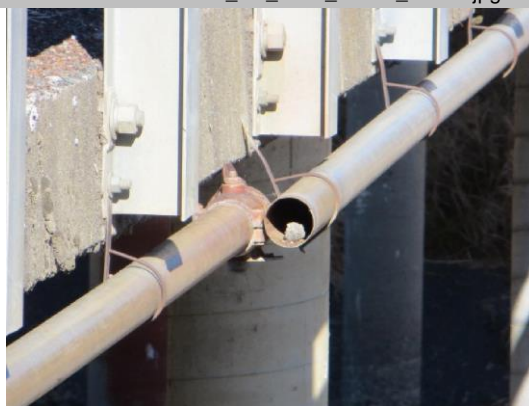
Photo 1 of 3 : UCIP\_SP\_2019\_26907\_49751.jpg

Pipe open on waterward end.

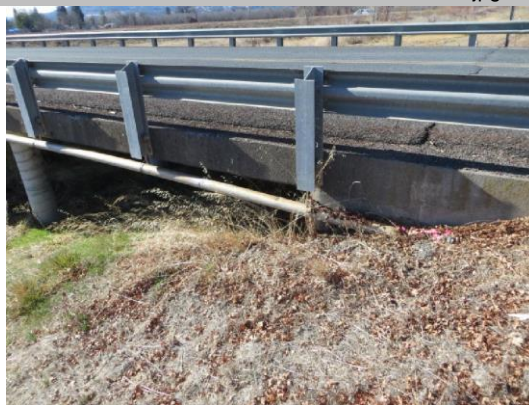
Photo 2 of 3 : UCIP\_SP\_2019\_26907\_49750.jpg

Pipe visible on upstream side of bridge.

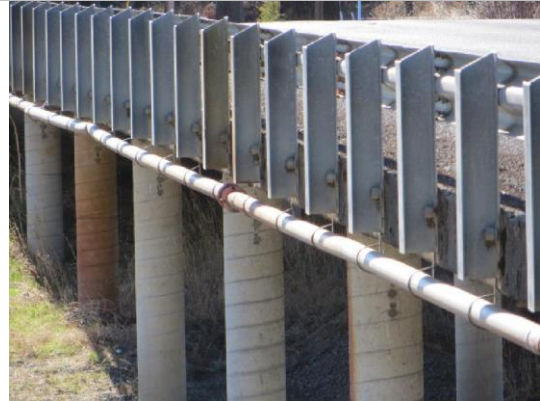
Photo 3 of 3 : UCIP\_SP\_2019\_26907\_49749.jpg

Pipe visible on upstream side of bridge.

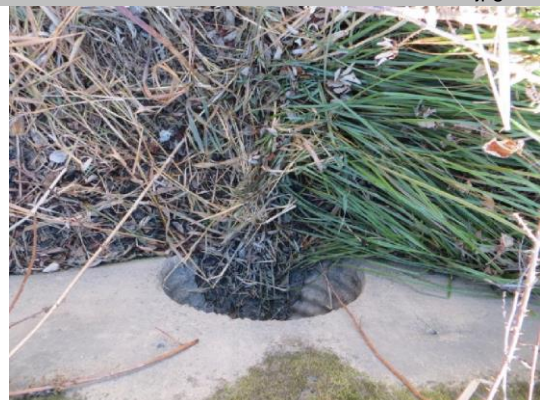
Photo 2 of 3 : UCIP\_SP\_2019\_53332\_49753.jpg

Pipe and concrete headwall visible in drainage channel on LS toe.

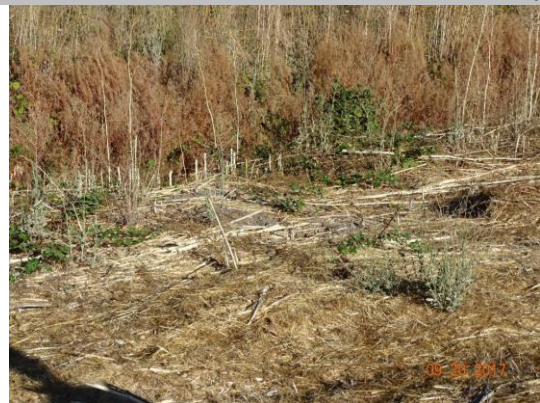
Photo 1 of 1 : SP\_2019\_NA0009\_6\_12\_20190411\_00005.jpg

View of the rodent holes along the landside slope &amp; toe. Fall 2017

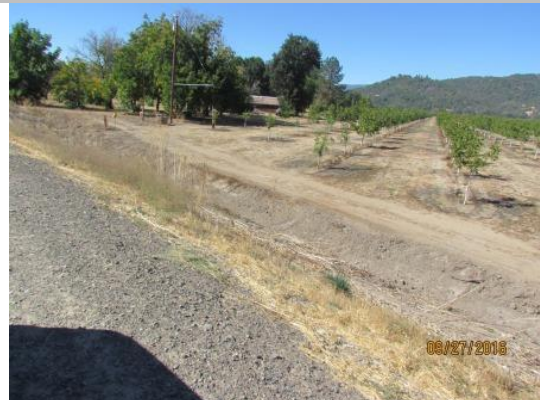
Photo 1 of 1 : SP\_2019\_NA0009\_6\_13\_20190411\_00006.jpg

View of a ditch at the landside toe looking downstream.

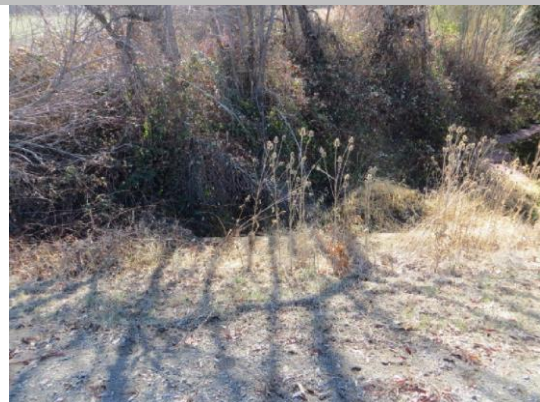
Photo 2 of 3 : UCIP\_SP\_2019\_26897\_49711.jpg

Outlet visible at concrete headwall on LS toe.

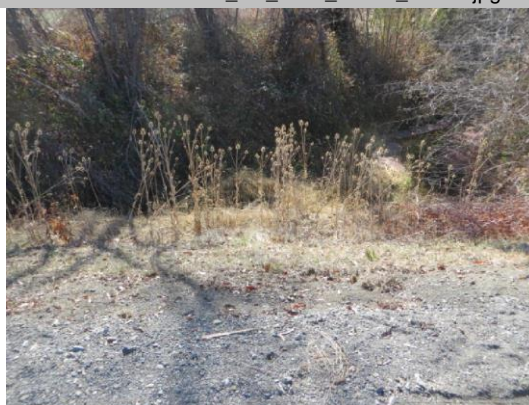
Photo 2 of 3 : UCIP\_SP\_2019\_26885\_49633.jpg

Outlet visible at concrete headwall on LS toe.

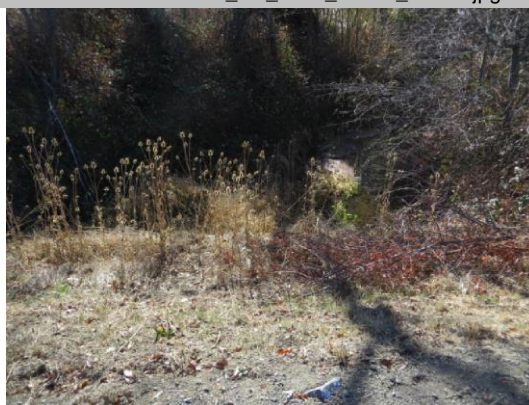
Photo 2 of 3 : UCIP\_SP\_2019\_26883\_49621.jpg

Pipe visible at concrete headwall on LS toe.

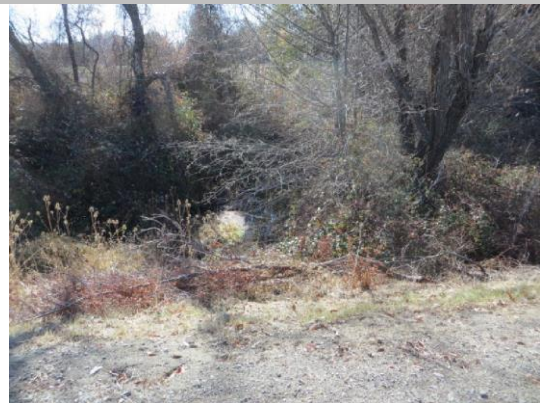
Photo 2 of 3 : UCIP\_SP\_2019\_26877\_49609.jpg

Concrete headwall on LS toe.

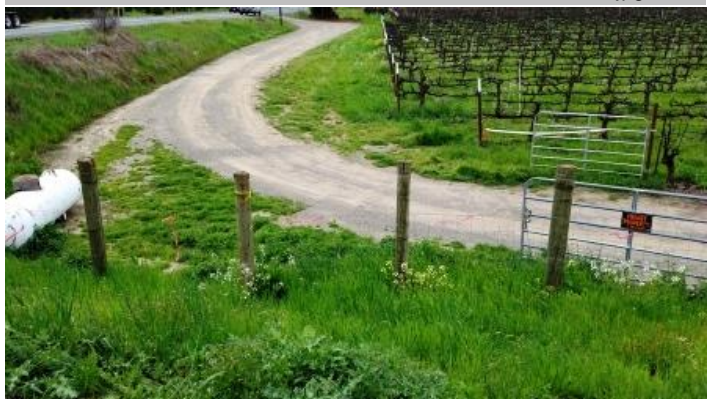
Photo 1 of 1 : SP\_2019\_NA0009\_7\_22\_20190415\_00026.jpg

View of landowner's fence posts placed at levee toe. Spring 2019
